Inspection Report

Property Address:

Any Address

RMG Home Inspections, Inc.

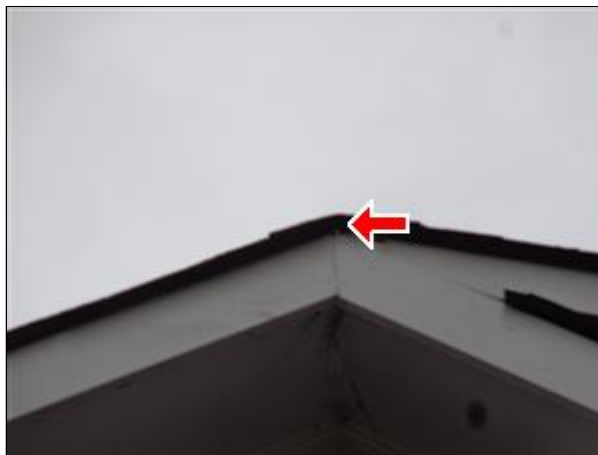
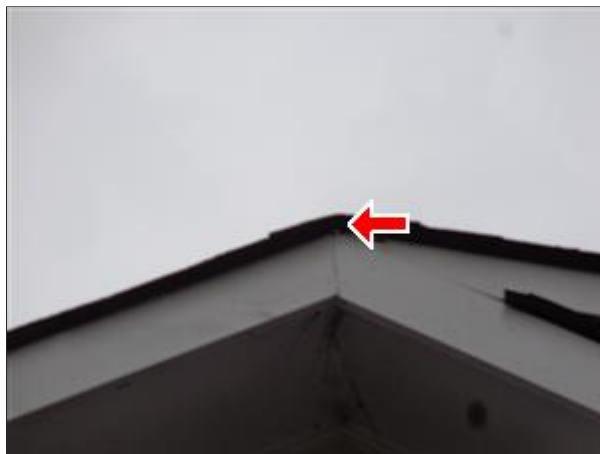
1.0 There is a broken shingle at the peak on the right end of the garage allowing water to get to the wood. The shingle at the peak on the right end of the garage needs to be repaired or replaced.(Picture 1)

1.0 Picture 1 The broken place in the shingle.

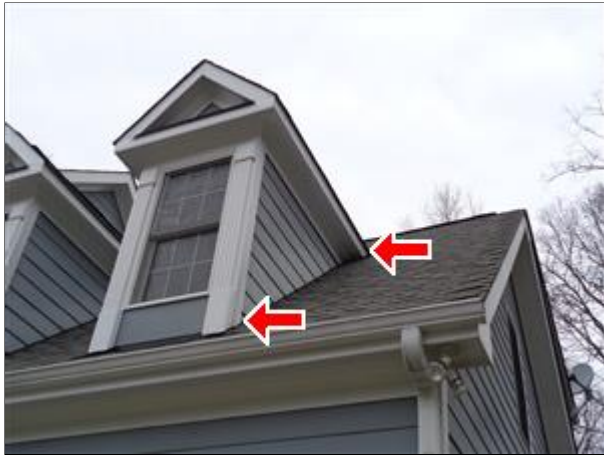
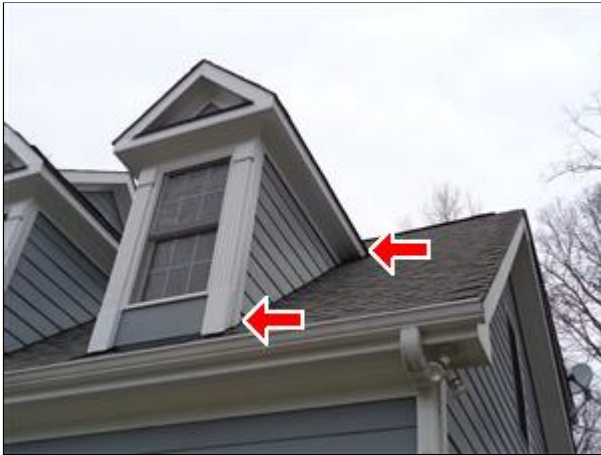
2.0 The corner boards for the dormers over the garage are deteriorated at the bottom and the facial boards are deteriorated at the end at the roof on each dormer. Water has entered to cause the deterioration. The corner boards and the facial boards need to be repaired or replaced on each side of each dormer(Picture 2)(Picture 3).(Picture 1)

2.0 Picture 1 The right side of the right dormer.

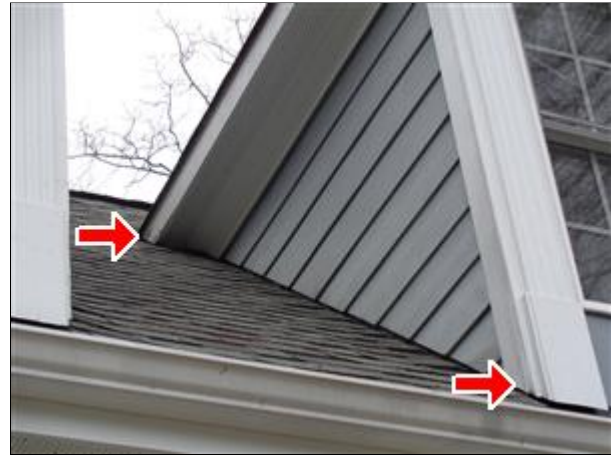
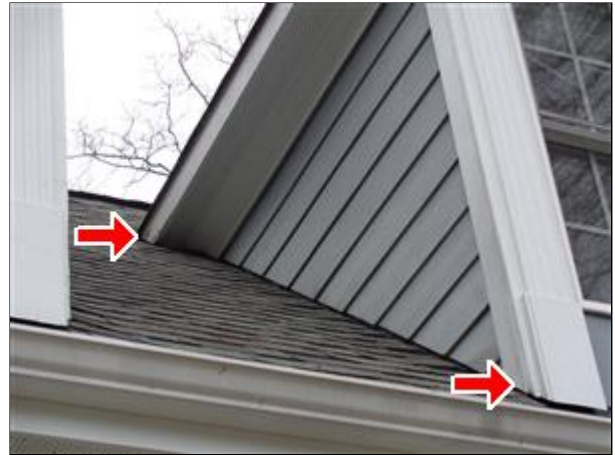
2.0 Picture 2 The left side of the left dormer.

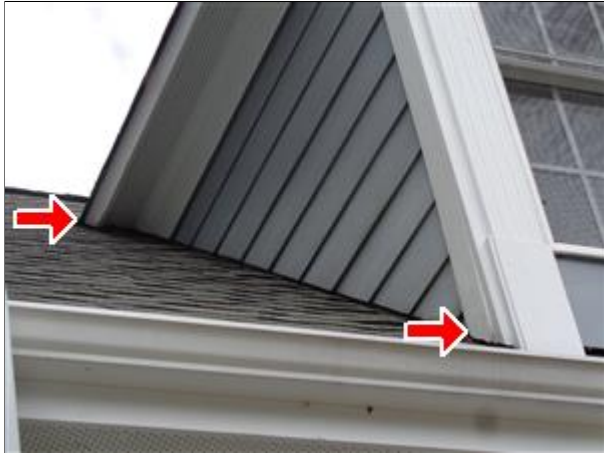
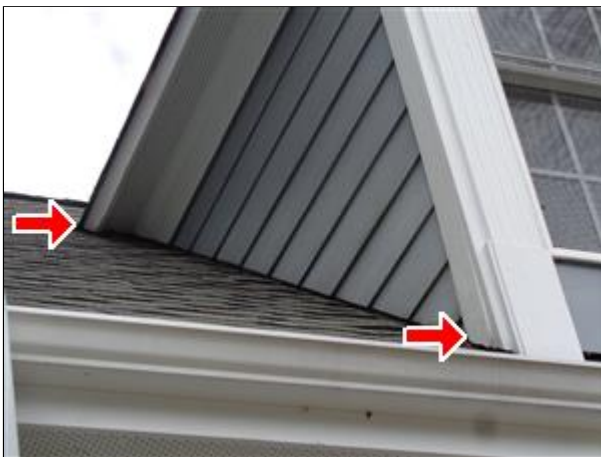
2.0 Picture 3 The left side of the right dormer.

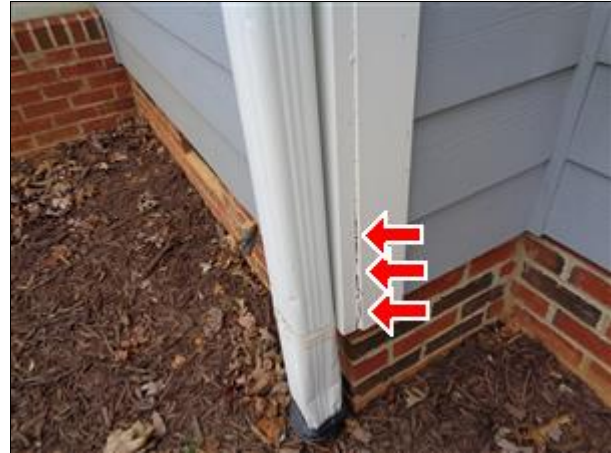
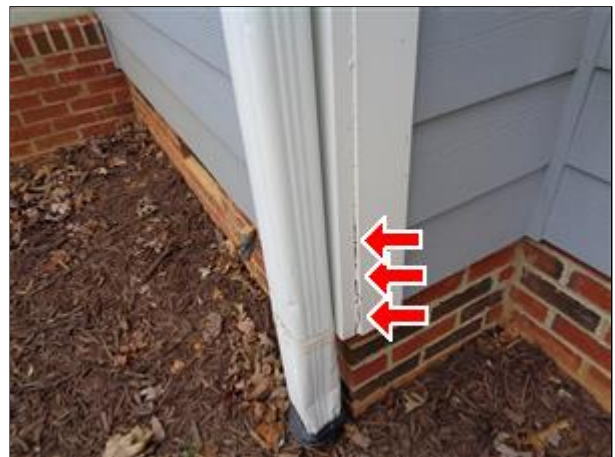
There is a crack at the joint where the two corner boards meet at the corner to the left of the garage door allowing water to enter. The crack at the corner board needs to be repaired.(Picture 4)

2.0 Picture 4 The crack at the corner board.

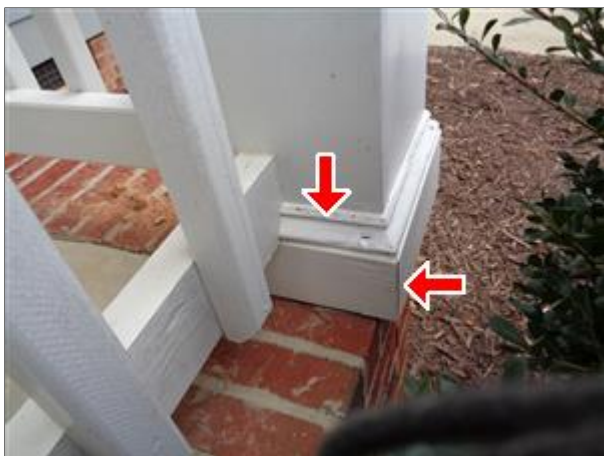
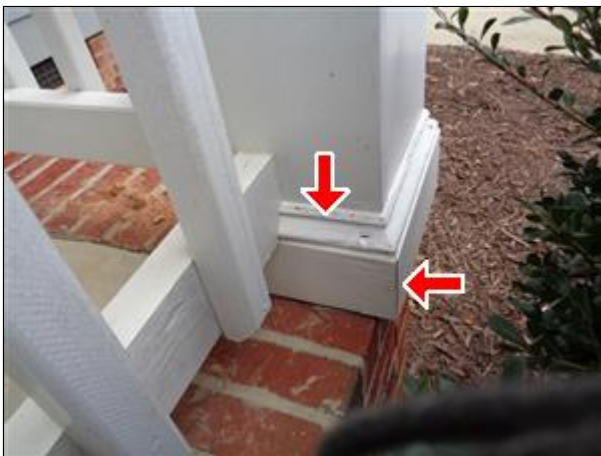
The trim around the right front column is deteriorated and there are cracks at all of the joints on each column for the front porch. Also the base of the post for the left rail on the porch is cracked. There is also missing paint on some of the railing. Water is getting to the wood at all of these places and deterioration will occur. The deteriorated wood needs to be replaced and all of the cracks at the joints need to be filled and painted.(Picture 5)(Picture 6)(Picture 7)

2.0 Picture 5 The deteriorated trim and crack at the joint at the right front column.

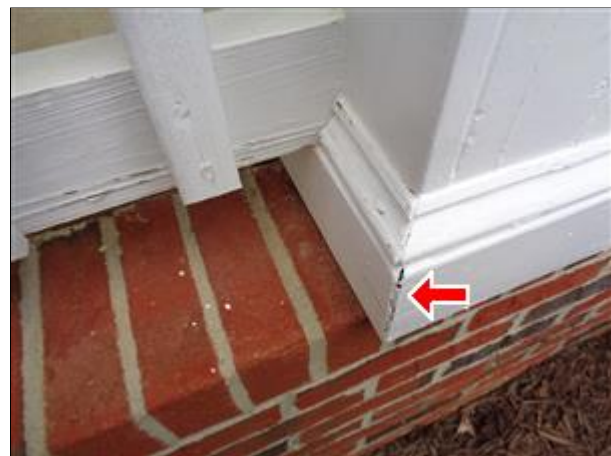
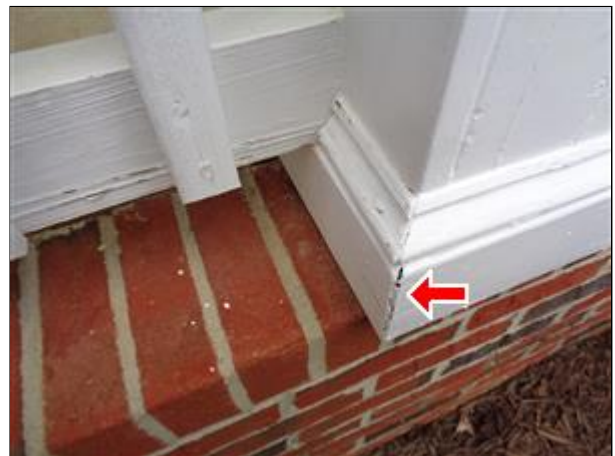
2.0 Picture 6 One of the cracks at the base trim for the column.

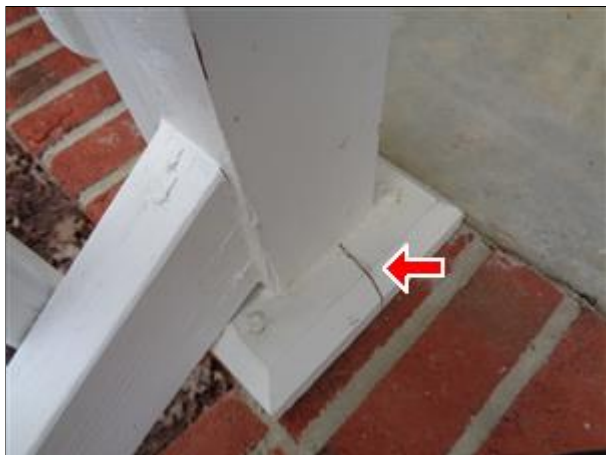
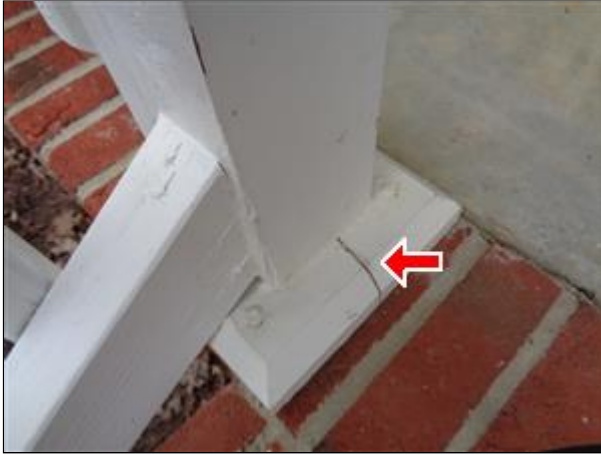
2.0 Picture 7 The split base plate for the left rail for the front steps.

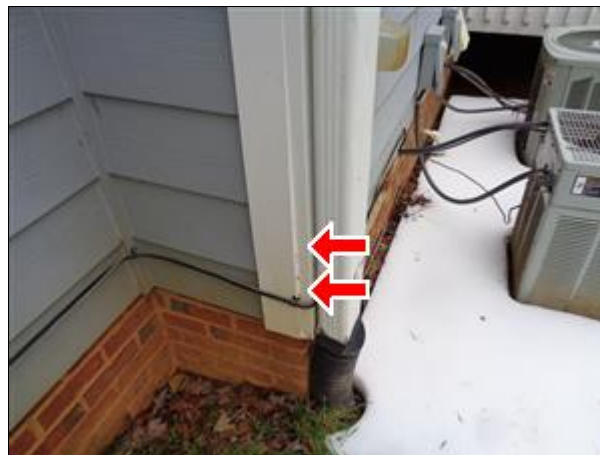
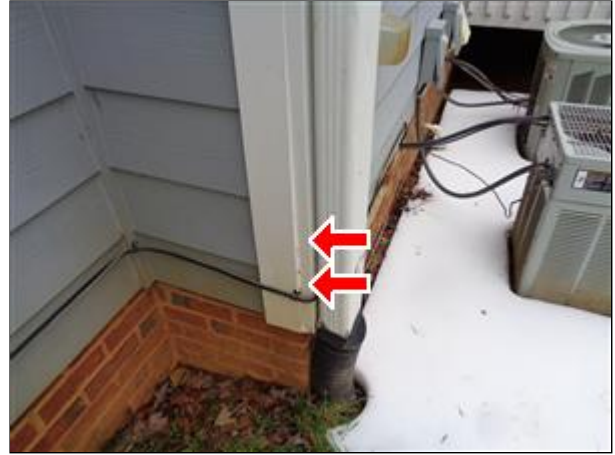
The right back corner board for the house near the AC units has cracked caulking allowing water to enter. The caulking for the corner board needs to be repaired.(Picture 8)

2.0 Picture 8 The cracked caulking.

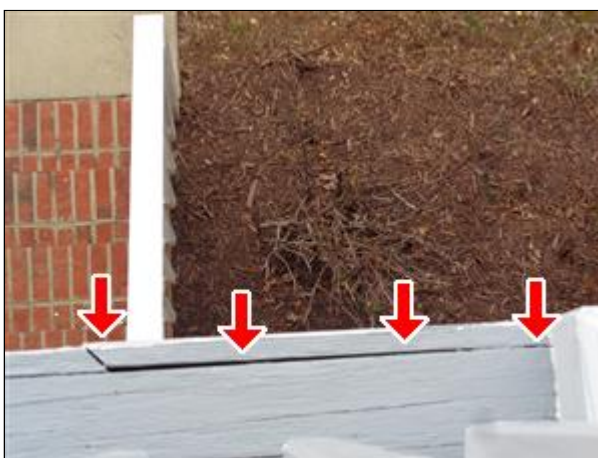
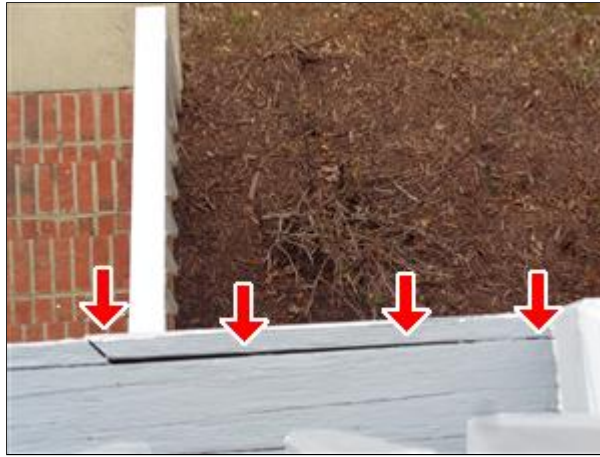
The board across the front of the second floor porch is not sealed so water cannot get to the framing. This will allow the wood beams to deteriorate. The floor for the upstairs porch appeared to be very wet and the wood did not appear to be

treated. If the wood is not treated it will deteriorate. The board across the front of the porch needs to be repaired and the flooring for the upstairs porch needs to be checked by a licensed contractor and repaired as needed.(Picture 9)

2.0 Picture 9 This is one area of the board across the front of the porch.

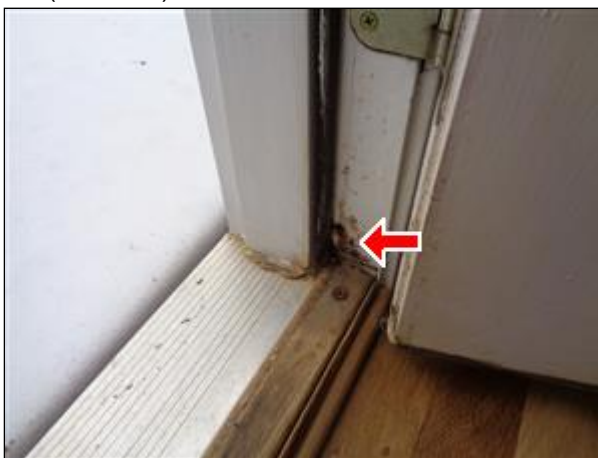
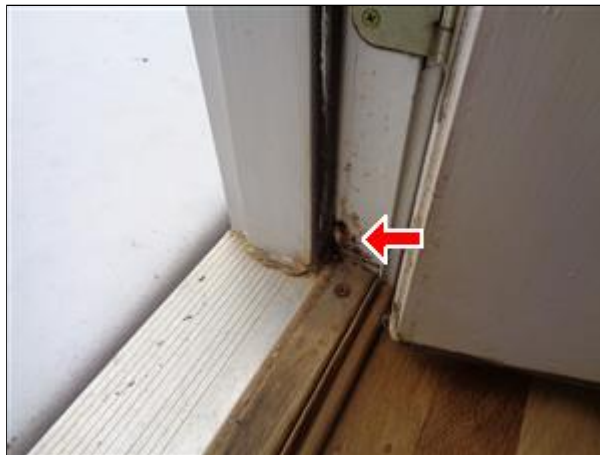
2.1 There is a deteriorated place in the door jamb on the hinge side at the bottom of the jamb for the back door. The deteriorated area needs to be repaired.(Picture 1)

2.1 Picture 1 The deteriorated in the back door jamb.

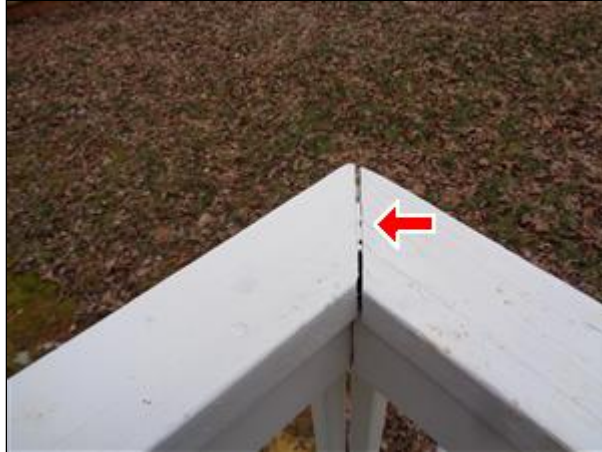
2.3 There is a crack at the corner joint for the top rail on the left side of the deck allowing water to penetrate the wood. The crack needs to be repaired.(Picture 1)

2.3 Picture 1 The crack at the corner of the top rail for the deck.

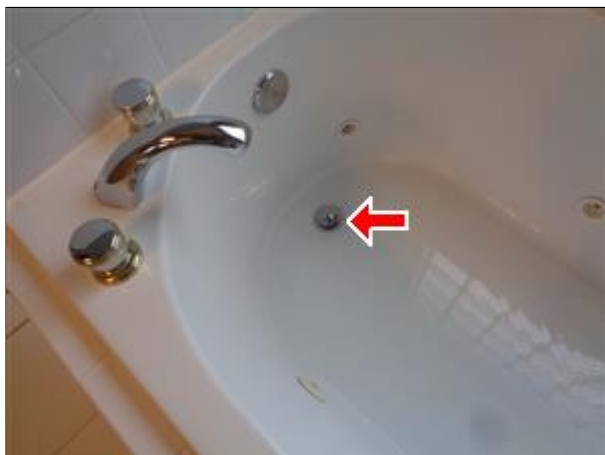
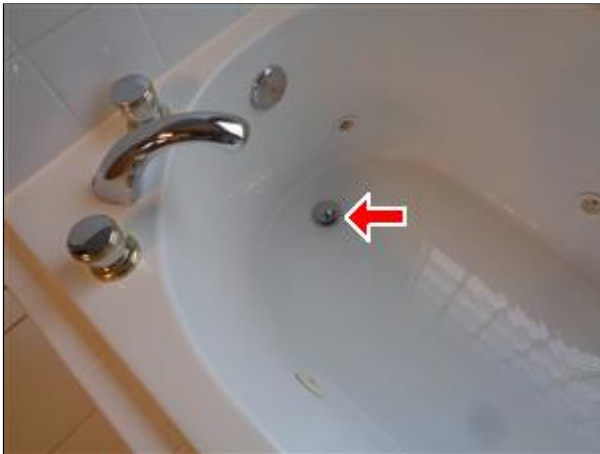
All of the drains were inspected and they all worked as intended except the drains for the upstairs tubs. The commodes cut offs worked as intended with no leakage at the stopper. There were no visible signs of leakage around the commode in any of the bathrooms

6.0 Picture 1 The tub in the master bathroom.

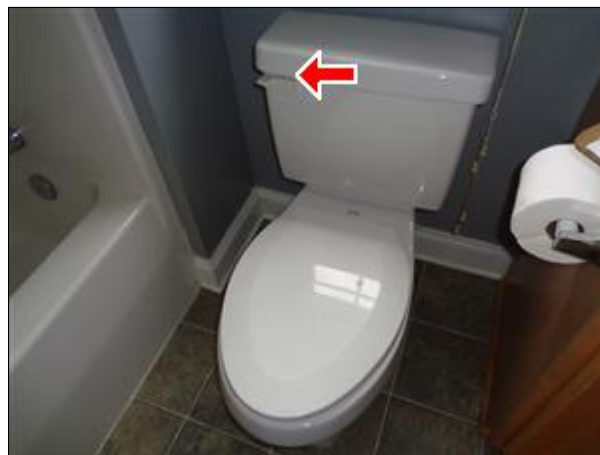
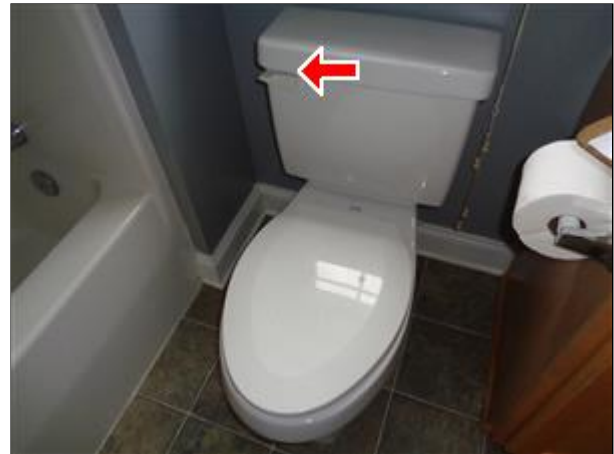
The commode in the hall bathroom upstairs will not flush unless the handle is held down. This is an inconvenience. The commode needs to be repaired so the commode flushes as intended.(Picture 2)

6.0 Picture 2 The commode in the hall bathroom upstairs.

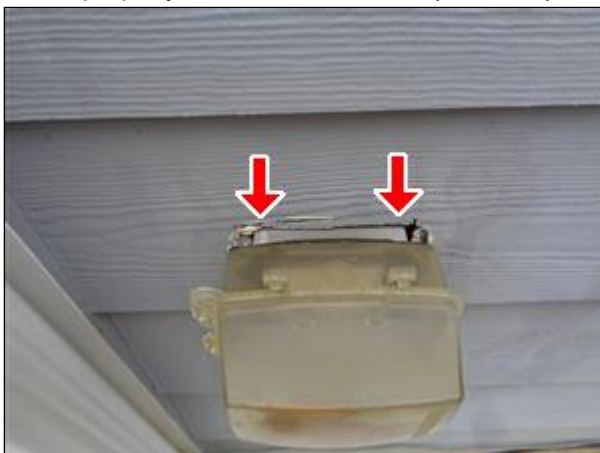
7.3 The receptacle box is not attached to the wall to the right of the AC units. This is a safety hazard if the box is pulled out of the wall. The electrical box needs to be properly attached to the wall. (Picture 1)

7.3 Picture 1 The electrical box on the back of the house.

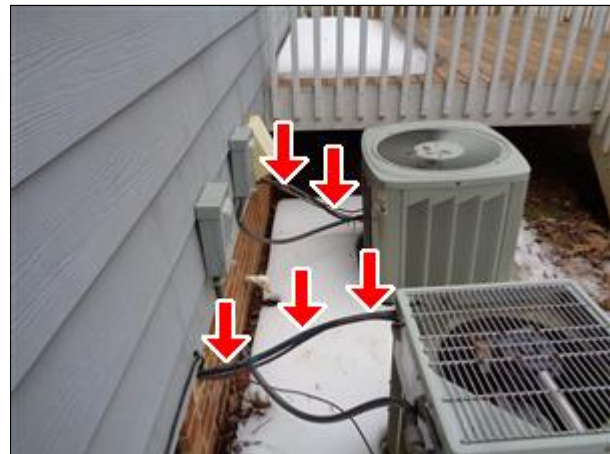
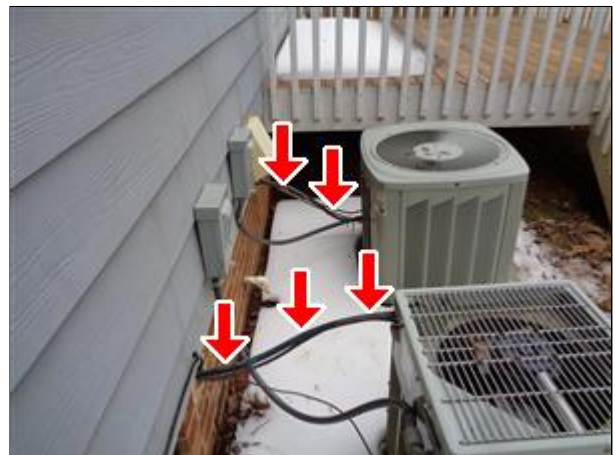
The freon lines are not covered going to the AC units. The lines need to be covered with the wrap to keep anyone from getting burned if the pipes were to be touched.(Picture 2)

8.8 Picture 2 The lines without the coverings.
